Attachment A: Digital Images

May 13th, 2008

BOE Building 20th Floor Break Room

Sacramento, CA

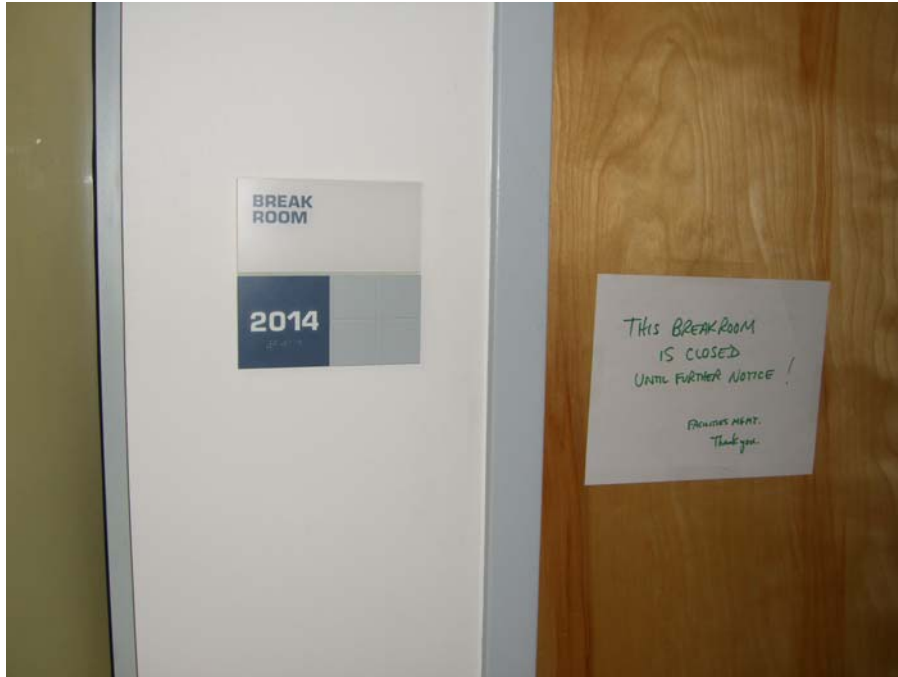
- 1) Image of entry to 20th Floor Break Room (2014) with BOE generated posting present on doorway at the time of BioMax's assessment.

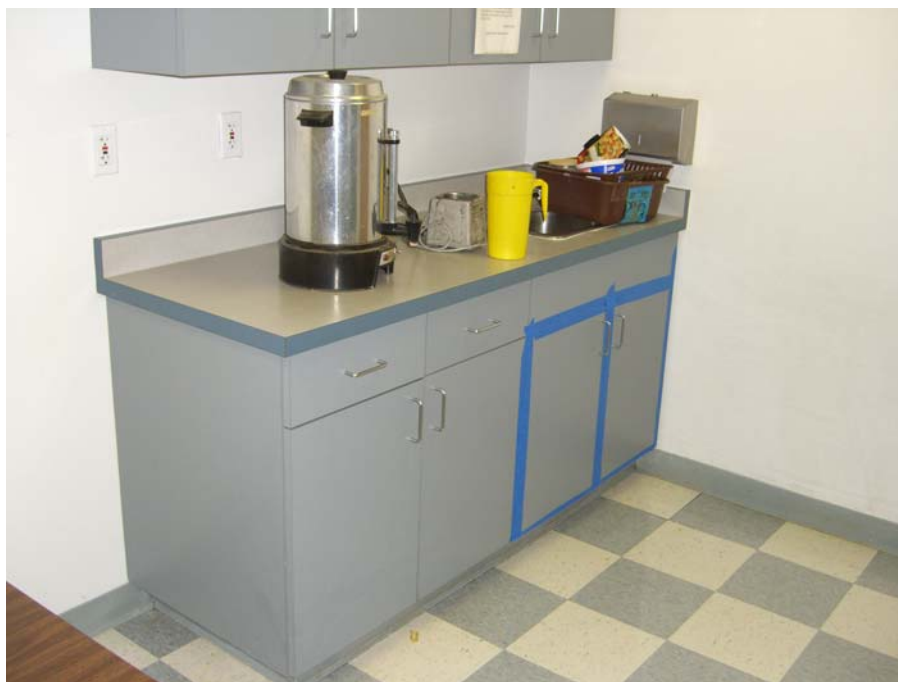
- 2) Image of Break Room cabinet at time of preliminary inspection. Blue tape present on impacted cabinet material as applied by BOE staff prior to BioMax's inspection.

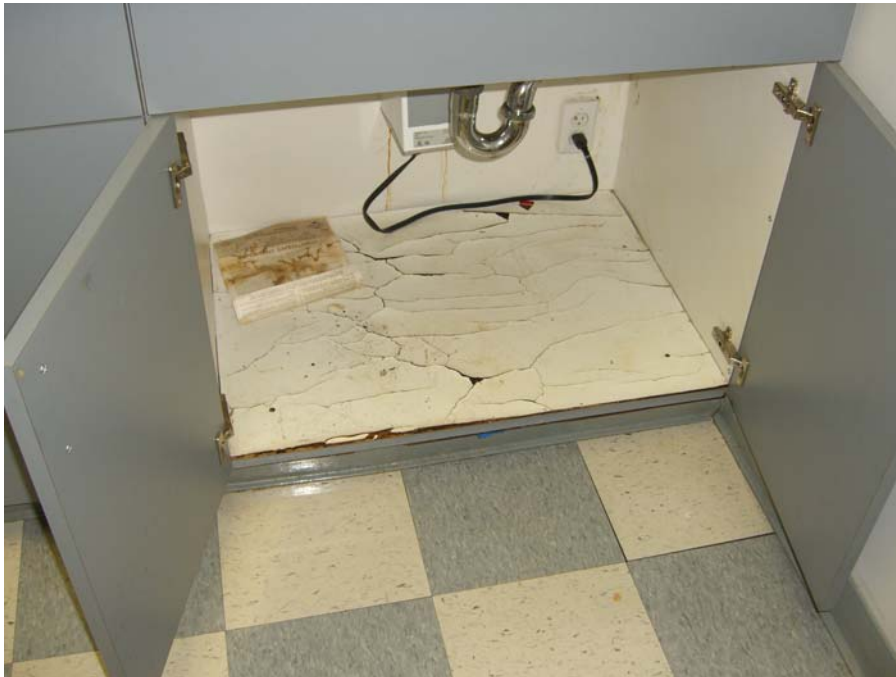
- 3) Image within cabinetry of Break Room upon removal of tape barrier. Note cracking and staining present on laminant cabinet base materials.

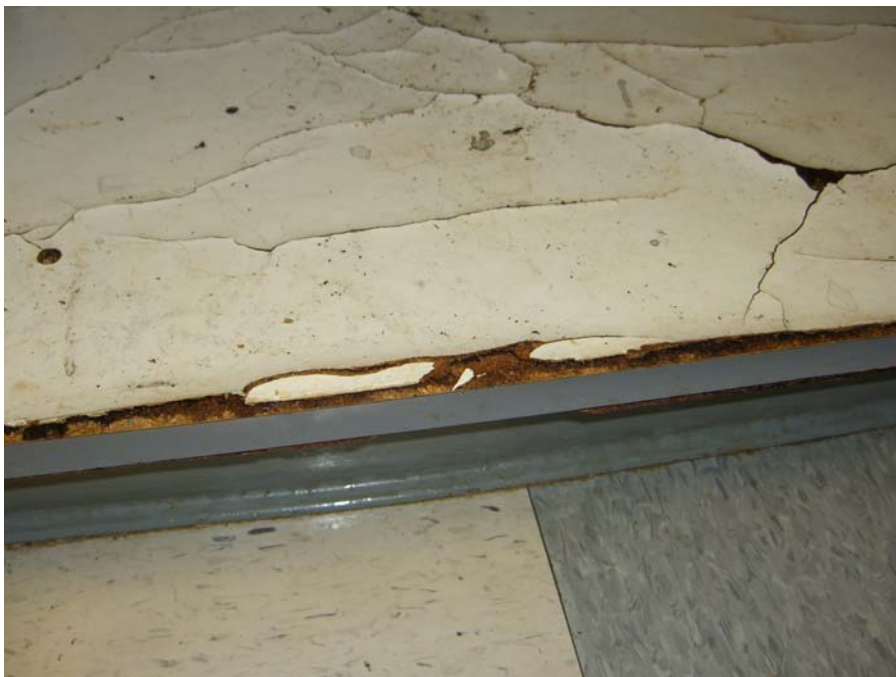
- 4) Close-up image of cracking and delamination within cabinet base materials. Note adjacent vinyl baseboard and tile flooring material delamination at time of assessment.

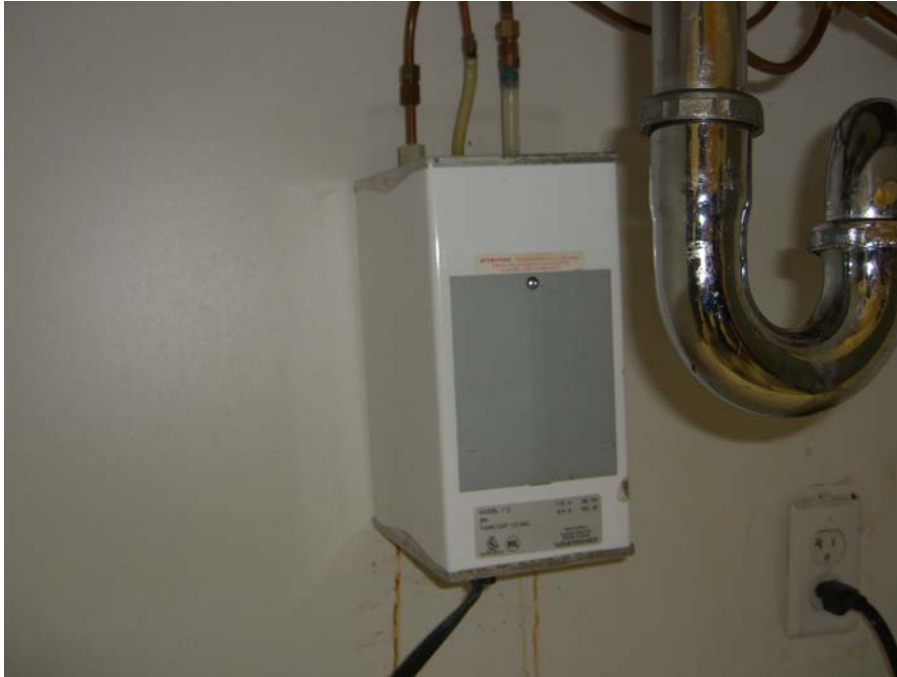
- 5) Image within sink cabinet of “Insta-hot” water treatment unit with staining along the rear vertical wall emanating from behind the noted unit.

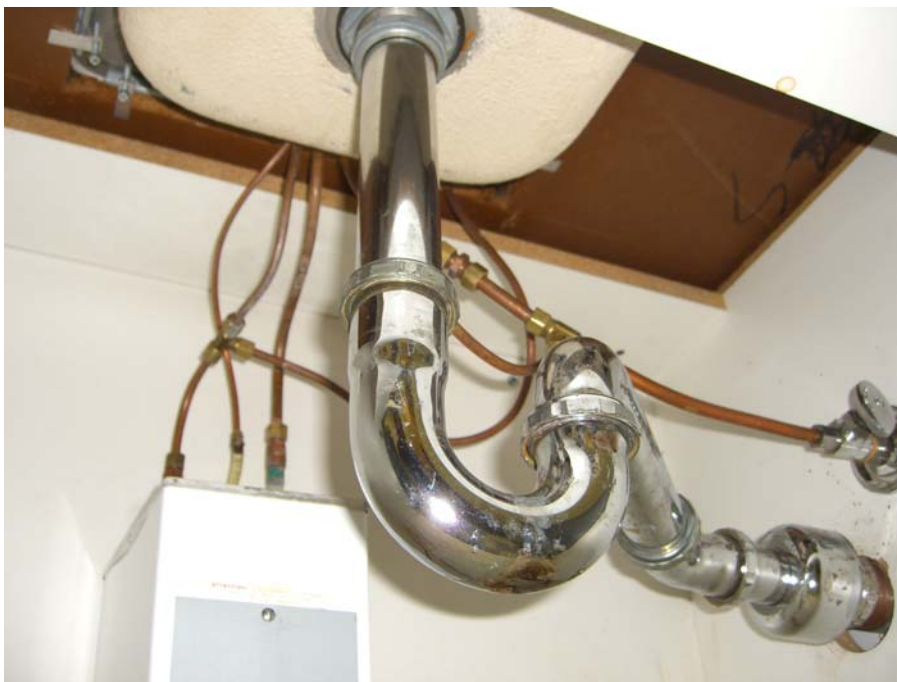
- 6) Image of sink insert base and plumbing within cabinet base. Evidence of historical leaking at base of “S” trap evident at time of assessment.

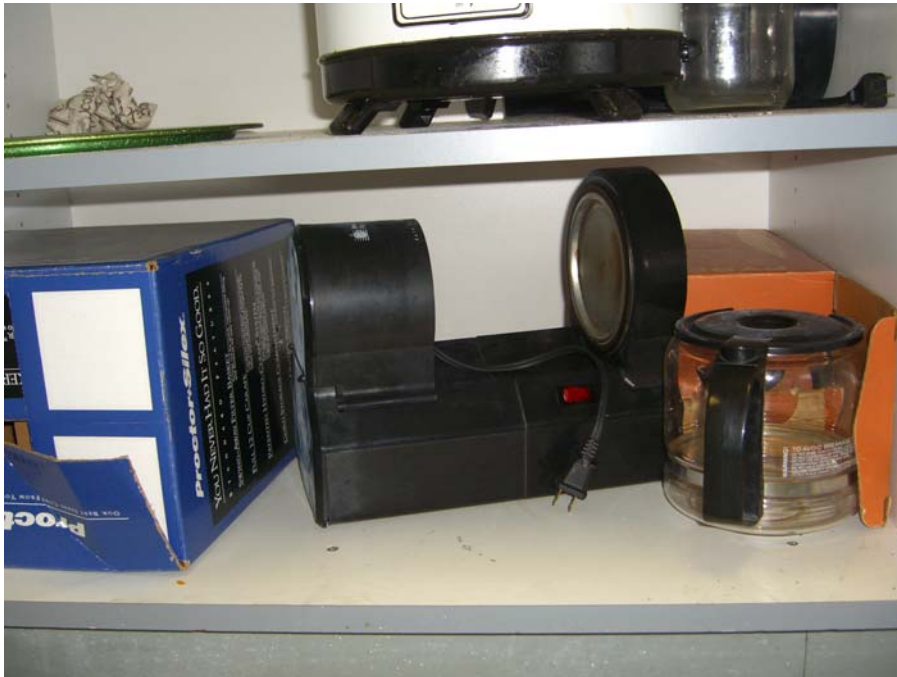
- 7) Close-up image of Personal appliances storage within adjacent cabinet compartment at time of assessment.

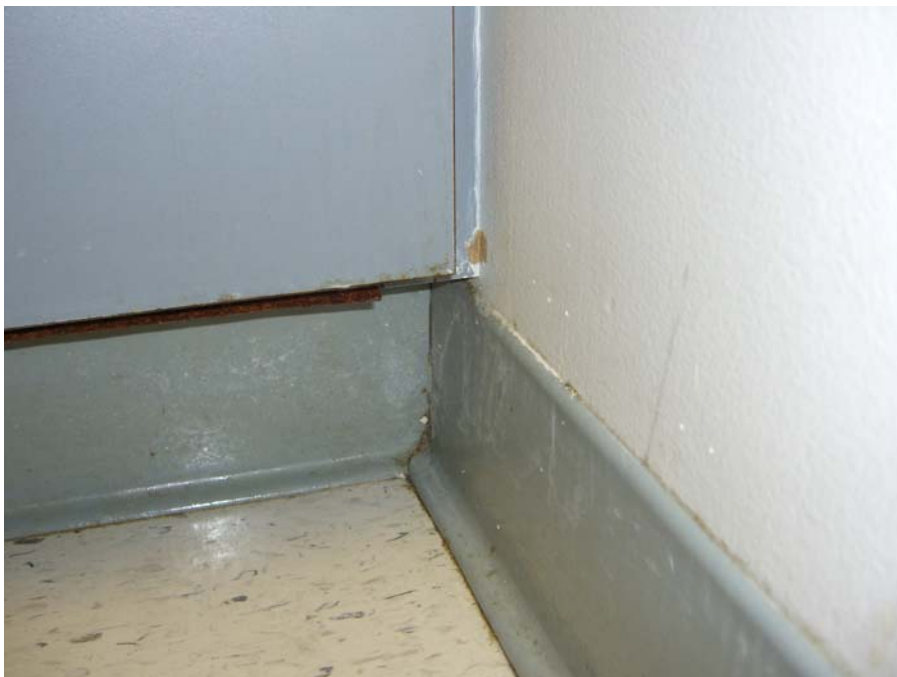
- 8) Image of right side of cabinet at floor level. Evidence of historical water staining present on cabinet door, vinyl baseboard, and floor tile materials.

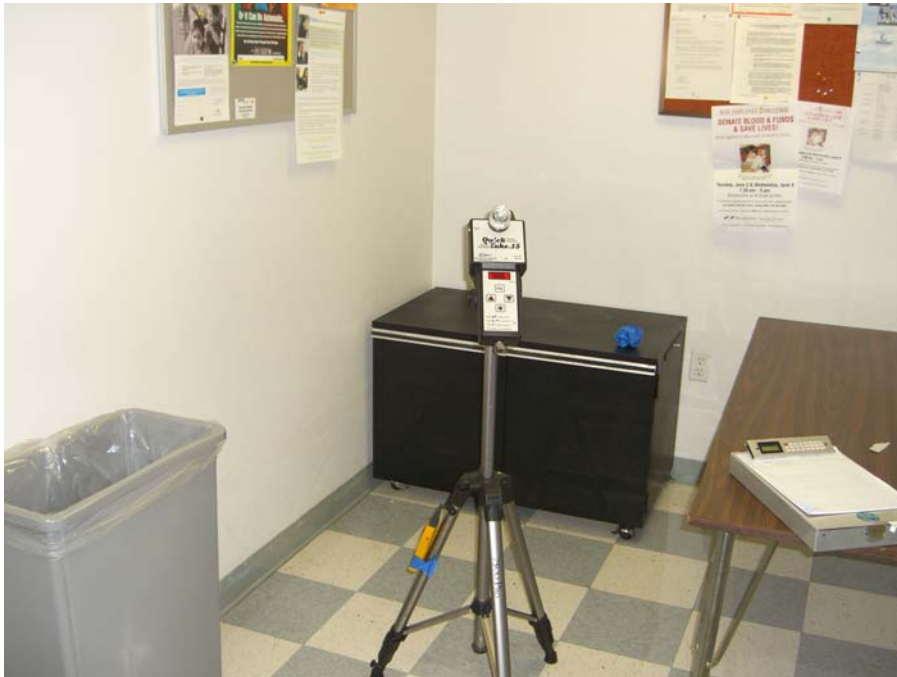
- 9) Image of air handling equipment utilized within break room and reference locations of existing furnishings where no evidence of moisture damages were noted at this time.

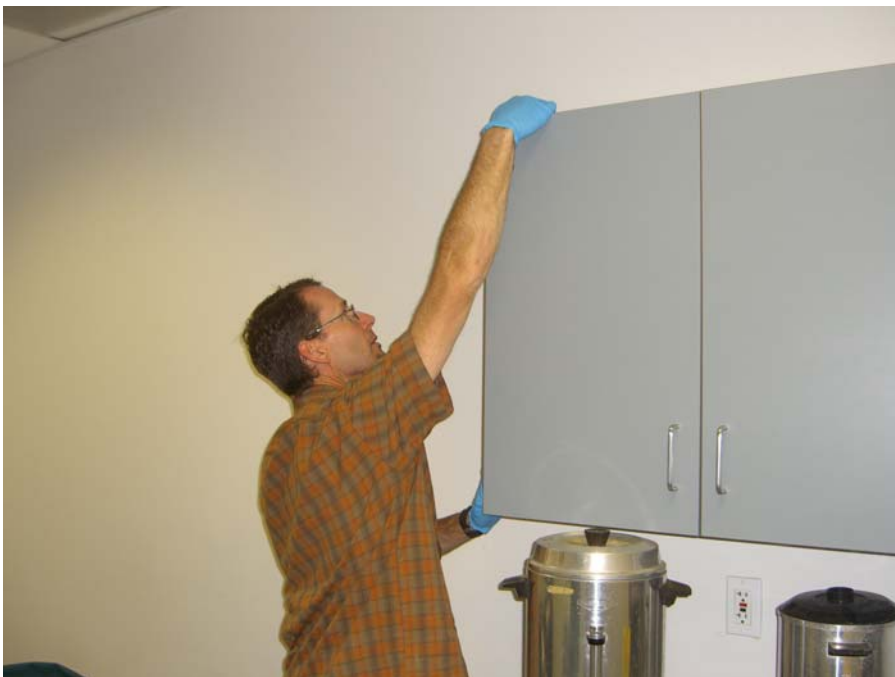
- 10) Image of Mr. Polkaba of BioMax collecting surface sample from representative material within break room not directly affected by moisture contact/release.

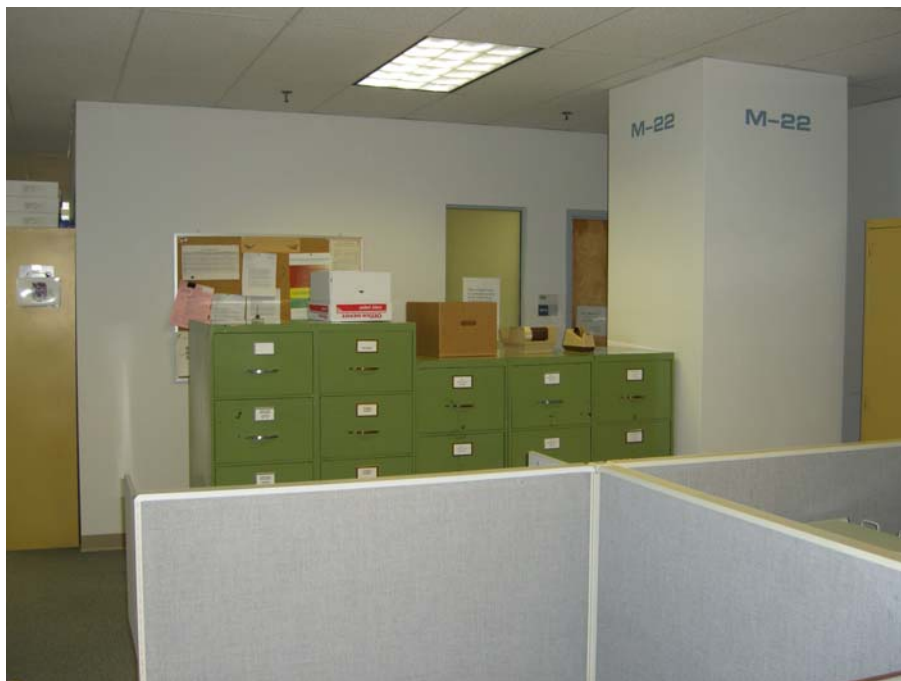
11) Image of occupied cubicle area adjacent to break room. Cubicle divider top frame in foreground served as a representative area for surface sampling and comparative analysis.

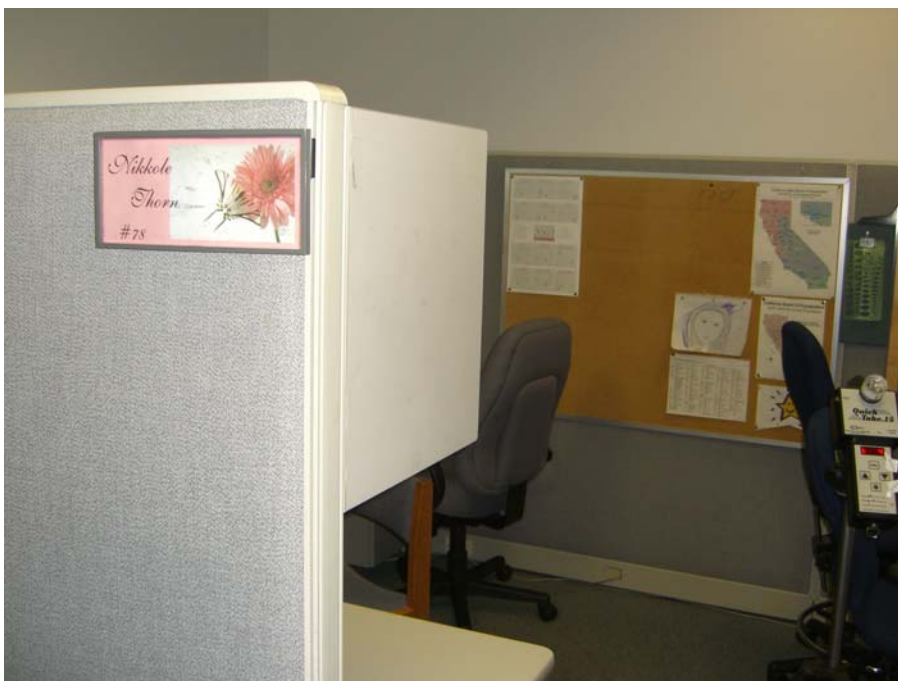
12) Image of air sampling activity performed within Nikkole Thom's cubicle area adjacent to (with shared rear wall) the break room.

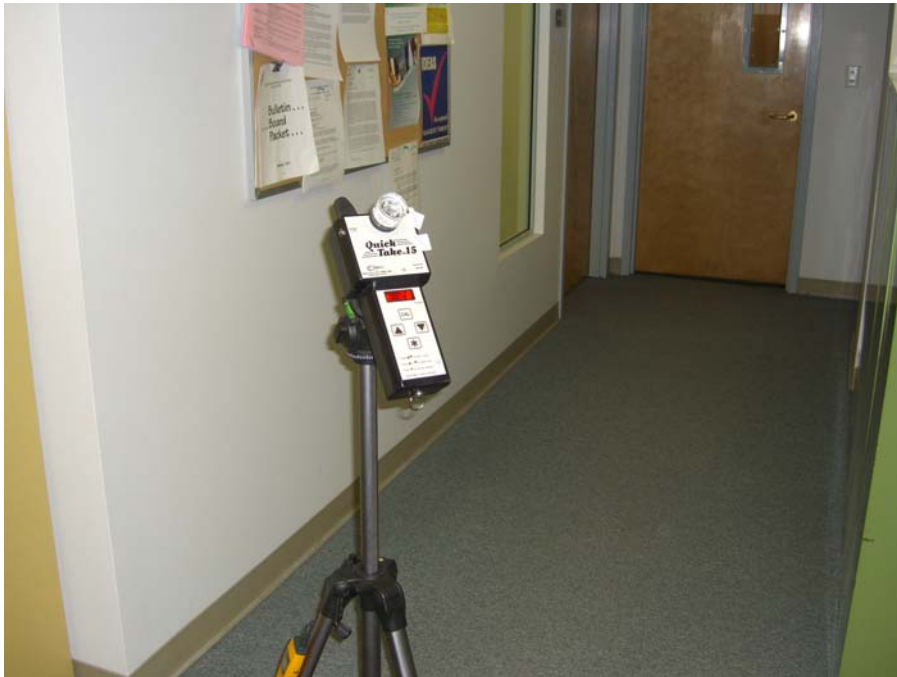
13) Image of air sampling activity performed within hallway of occupied cubicle area adjacent to break room.

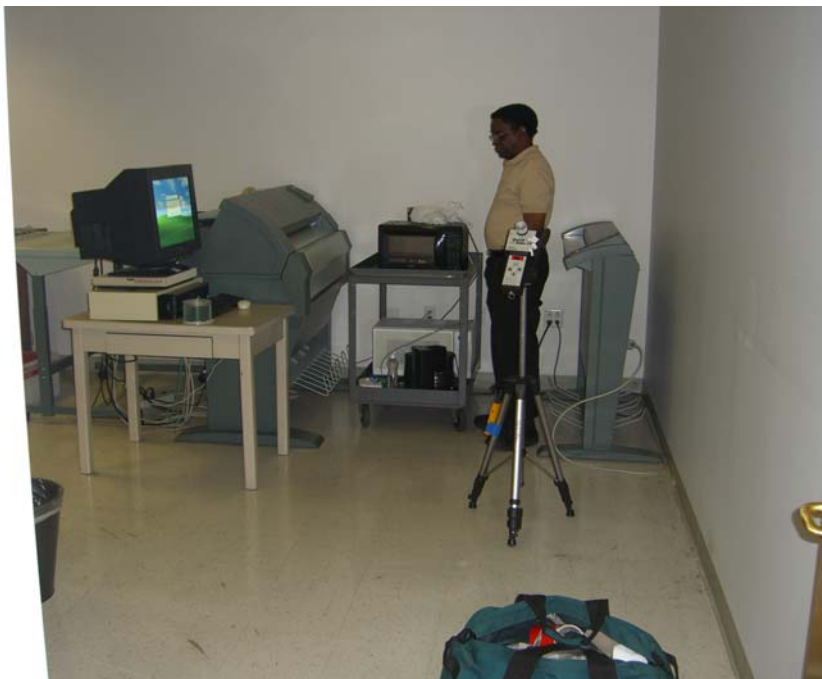
14) Image of air sampling activity performed within MAP Scanning room (#2013) adjacent to (with shared rear wall) the noted break room.
